RELEASE NOTE SUMMARY

iBRID™ MX6

Overview

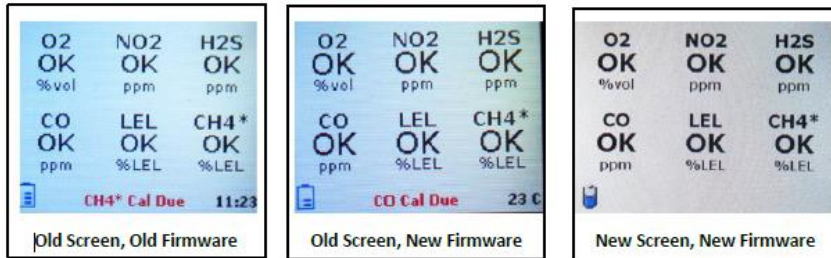
1. Increased Text Font Size and Clarity

Two significant improvements have been made to the MX6 display. First, a new higher-resolution TFT LCD display will replace the now obsolete CSTN LCD previously used in the MX6. The new LCD will provide crisper, easier-to-read text even in bright sunlight. Second, the font size on both LCDs is now noticeably larger.

Please note the new LCD has not been approved by MSHA or China MA yet

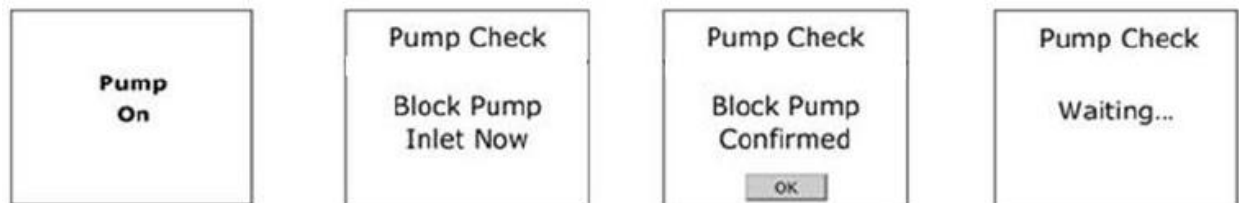
2. New Pump Test at Startup Required in Aspirated MX6s

To ensure the safety of our customers, the MX6 will require users to block the pump during startup prior to advancing to the Normal Reading Screen. If the user does not acknowledge the screen prompts, the instrument will go into low alarm. This feature was added to notify customers of pump failures before entering unsafe environments, especially those working in high noise environments. This feature is disabled when connected to a docking station.
